Welding and Corrosion Performance of INCO-WELD 686CPT Filler Metal In Waste-To-Energy Power Plants

Christopher E Thornton ^{*1}, Craig Cooper ²

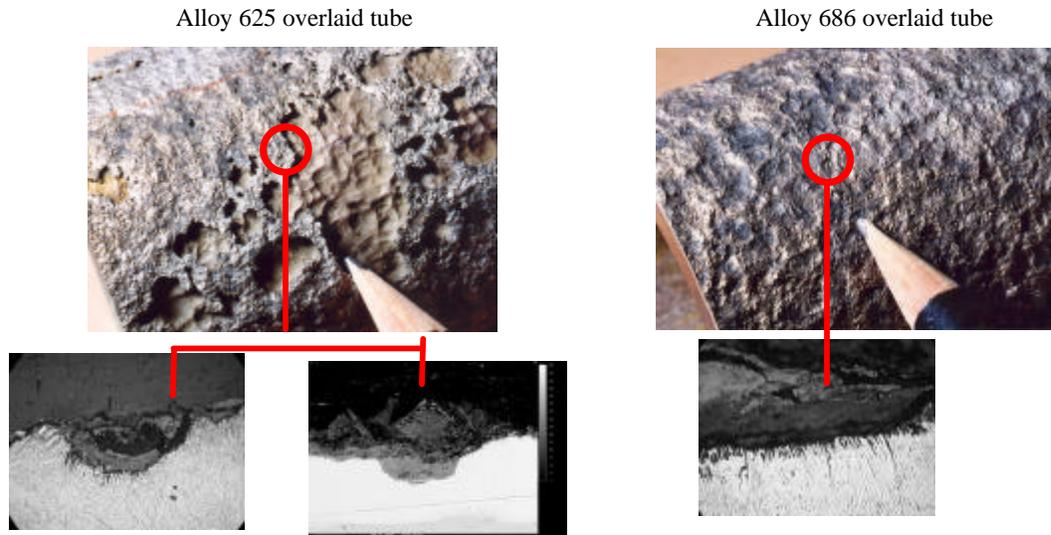
Large areas of penetrating corrosion were experienced (Fig. 1) with areas of overlay completely removed such that the carbon steel tube beneath the overlay was exposed and available for rapid corrosion and consequent penetration of the tube wall. Pitting of the surface was observed with a morphology consistent with the predominant corrosion mechanism being by chloride rich salt melts. Examination of the metal interface within the pitted regions also showed some preferential corrosion within the dendrite cores, consistent with gaseous chlorine attack.

Whilst the tube suffered from extensive general corrosion, the overlay remained intact without any penetration to the substrate tube. There is limited evidence of pitting of the surface from chloride salt melt attack. The metal interface shows leaching of the dendrite cores through gaseous chlorine attack.

Figure 1 – Overlaid tubes removed from WTE boiler after 8,000hours of operation.

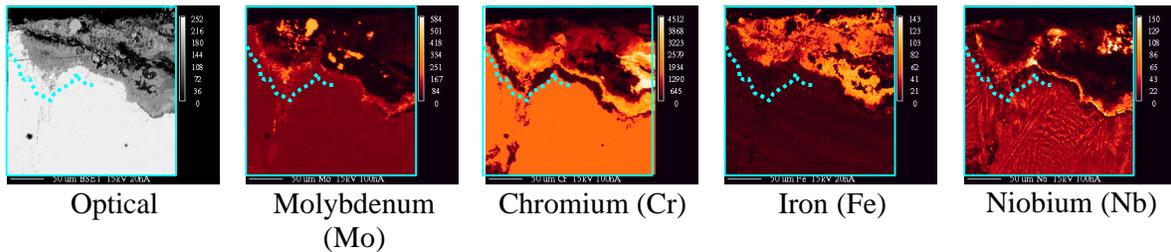
Electron microprobe analysis of the overlaid surface (Fig. 2) and adjacent salt deposits clearly demonstrates that the elements iron, manganese, chromium and niobium are transported away from the corrosion interface thus offering little or no inhibiting resistance to corrosive attack. There is evidence that molybdenum, which has been leached from the alloy matrix, forms a partial boundary layer at the interface. The metal chlorides (of Fe, Cr, Mn etc), which are transported in the salt deposits away from the corrosion interface, become oxidised in the upper regions of the salt deposit leading to regeneration of the chlorine, which is free to return to the corrosion interface.

Figure 2. Element microprobe analysis of alloy 625 overlay after removal from the WTE boiler. (Bright areas indicate regions of maximum element concentration; blue line indicates corrosion interface)

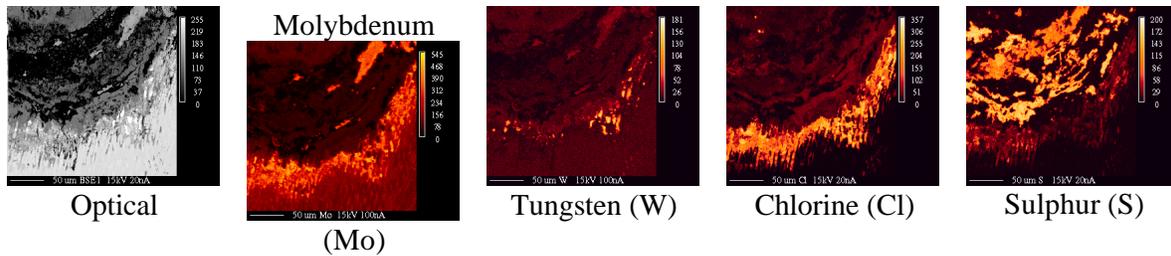
For the alloy 686 overlay the elements molybdenum and tungsten remain in the corrosion zone (Fig. 3) whilst the other elements are leached out in the same manner as for alloy 625. Additionally, there is evidence of chlorine/chloride enrichment at the corrosion interface. It is postulated that a protective film, comprising primarily molybdenum but also tungsten oxychloride at the corrosion interface, protects the alloy from further attack by free chlorine or salt melt. Sulphur was found to be present in the salt melt in regions away from the corrosion interface, and although it is not directly involved in the metal salt reaction at the interface, it is strongly involved in the inter-slag reactions, supporting the corrosion mechanisms associated with chlorine.

Figure 3. Element microprobe analysis of alloy 686 overlay after removal from the WTE boiler. (Bright areas indicate regions of maximum element concentration)
