NICKEL ALLOY WELD OVERLAYS IMPROVE THE LIFE OF POWER GENERATION BOILER TUBING

Rengang Zhang and Samuel D. Kiser
Special Metals Welding Products Company
1401 Burris Road
Newton, NC 28658

1. Abstract

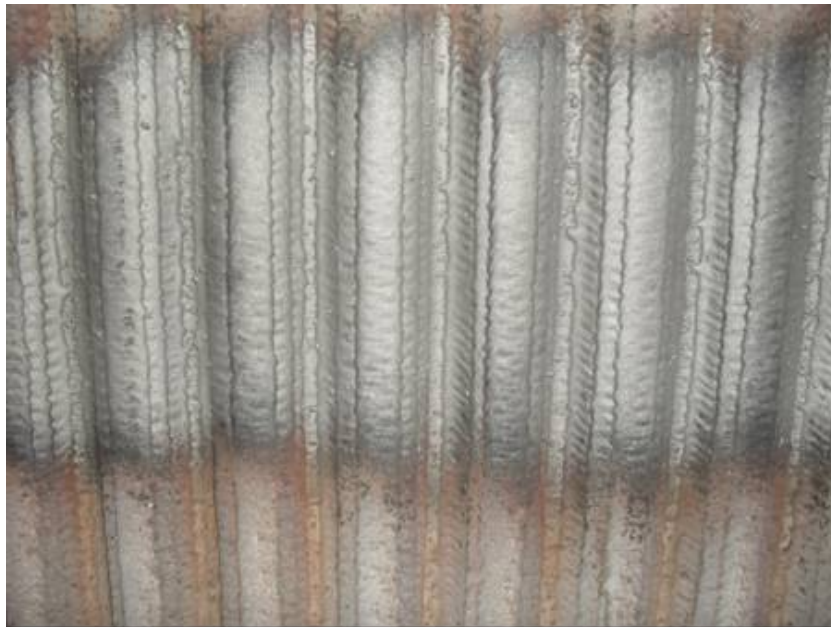
scrubber in nearly continuous service for 7-1/2 years. Neither circumferential nor longitudinal cracking of the waterwall tube overlay was observed. Fig. 1 shows grit blasted exposures of one location of three elevations including areas at each of the end walls where highest corrosion rates have been encountered. Even in highest corrosion rate areas, no beads were observed without original solidification ripples. Some were quite smooth yet faint indications of ripples were present. On the other hand, most of the overlays exhibited well defined ripples with only slight corrosion/erosion loss with no cracking observed at any location within the 5000 square feet of overlay.

Fig. 1. Grit blasted section of waterwall section weld overlaid with FM 52 from AEP Muskingum River #5.

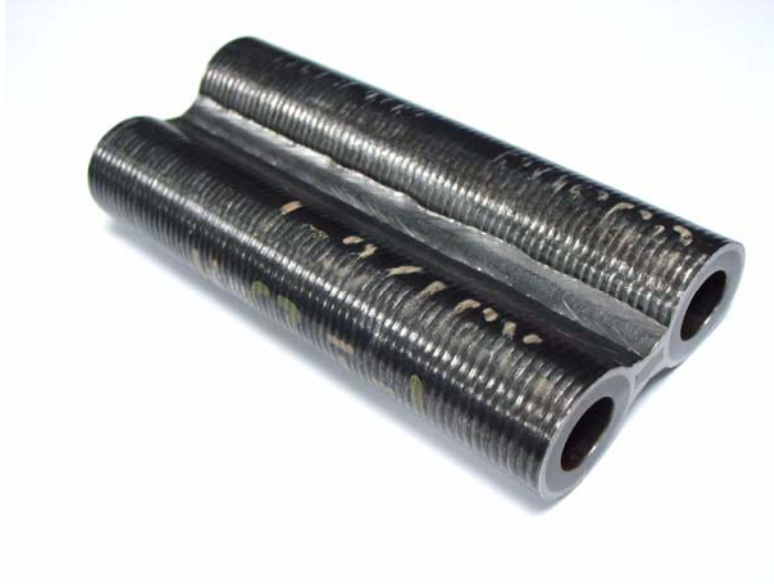
While there are test patches of INCONEL Filler Metal 72 and INCONEL Filler Metal 72M on waterwalls with very good reports to date, there are no large deposits with extended service from which to draw conclusions regarding performance. A ten tube by 40 foot long test panel has been installed in Gibson Station Unit Number 1 of the Duke Energy System (650 MW supercritical plant operating with 3500psi and 1005°F steam). Fig. 9 shows the qualification weld overlaid sample that represents the test panel that has been installed. While evaluation of waterwall installations incorporating Filler Metals 72 and 72M are on-going, there is an extensive body of data which reports robust performance of FM 72 (AWS ERNiCr-4) when used in superheater and reheater overlays. Fig. 10, 11, and 12 show sections of these upper boiler overlaid tubes after 28 months, 2+ years, and 6 years of service respectively. Fig. 11 shows a tube bend section which was given a simulated weld repair via SMAW using WE117 electrode; dye penetrant testing revealed no cracking in the repaired area. Fig. 12 shows the thickness profile and hardness level of a reheater tube which was in service for 6 years in a low-NO_x boiler with an estimated metal temperature at 1200-1250°F. The hardness ranged from Rockwell C 46-52. This increased hardness served to enhance erosion resistance. There is a wealth of additional data for FM 72 overlaid INCOLOY 800H that is reported in the B&W- OCDO-DOE study reported by McDonald and Robitz [3]. These data were generated by exposing the overlays to approximately 1200F. for 1, 2, and 3 years into a boiler environment generated by burning 3.5% S Ohio coal. Overall, the corrosion rates experienced by superheater and reheater overlays of FM72 is about 1-2mils/year with no cracking of the FM 72 overlays. By comparison, FM 52 overlays exposed to the same environment perform well, but not enough to serve for 10 to 20 years as would be desired for upper boiler tubulars.

Fig 9. Waterwall panel section overlaid using INCONEL Filler Metal 72M via the automatic GTAW process. The membrane weld was performed using the SAW.

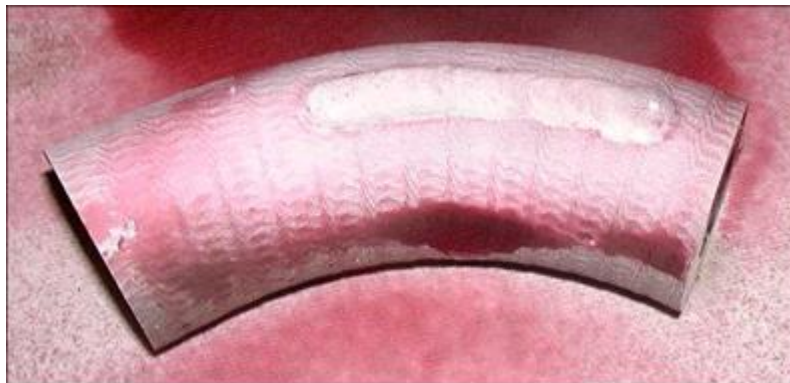
Fig. 11. Reheater tube overlaid with filler metal 72 after 2+ years in low-NO_x boiler service, showing a simulated repair via SMAW using WE117. Dye penetrant testing shows no cracking.

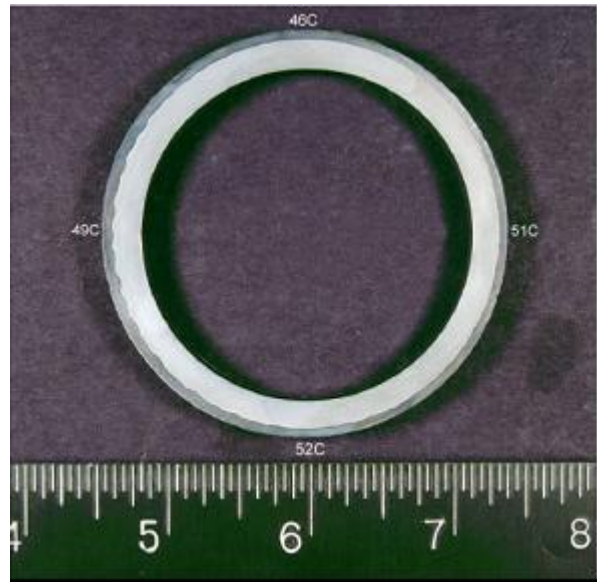
Fig. 12. Reheater tube overlaid with filler metal 72, removed from low-NO_x boiler service after 6 years of service. Note overlay integrity and erosion-enhancing hardness levels.

After extended service at typical operating temperatures, changes in the properties of filler metal 72 and 72M products have been observed. Fig. 12 has already shown the hardness increase that can be observed in filler metal 72 after extended exposure. The atomic nickel-chromium ratios in filler metal 72 and 72M are nominally 1.22:1 and 1.14:1 respectively. This would imply that both materials would be subject to long-range ordering. A study by Marucco showed that long-range ordering in Ni_2Cr occurs in 100-1000h below 977°F (525°C), and at 30,000h in Ni_3Cr , accompanied by a significant decrease in electrical resistivity [4]. Filler metals 72 and 72M, at $\text{Ni}_{1.14}\text{Cr}$ and $\text{Ni}_{1.22}\text{Cr}$, respectively, would yield different responses still. Fig 15 and 16 illustrate the measured drop in electrical resistivity (at room temperature) observed in Filler Metals 72 and 72M, respectively, after exposure under various conditions. Figure 17 illustrates the correlation between electrical resistivity and thermal conductivity (room temperature data are shown) for a variety of materials.

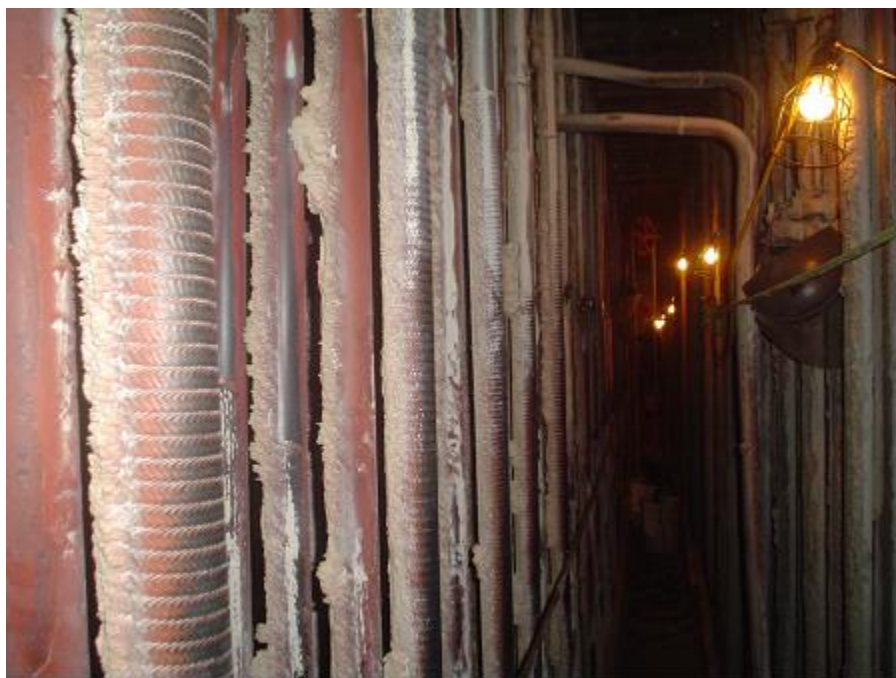
The final information to report on superheater tubes is the outstanding performance of FM 72 overlaid superheater tubes at AEP’s supercritical Rockport #1 Station (operating at 1010°F (543°C) at 26.5 MPa) that were used as soot blower lane superheater tubing. Fig. 13 and 14 show overlaid tubes that have been in service (at the time of photograph, about 7 years), but now about 9 years. Note the strong appearance of ripples still existing after years of harsh service from soot blowing.

Fig.13. SA213-T2 superheater tubes overlaid with filler metal 72, after 7 years of service in AEP's Rockport #1 plant.

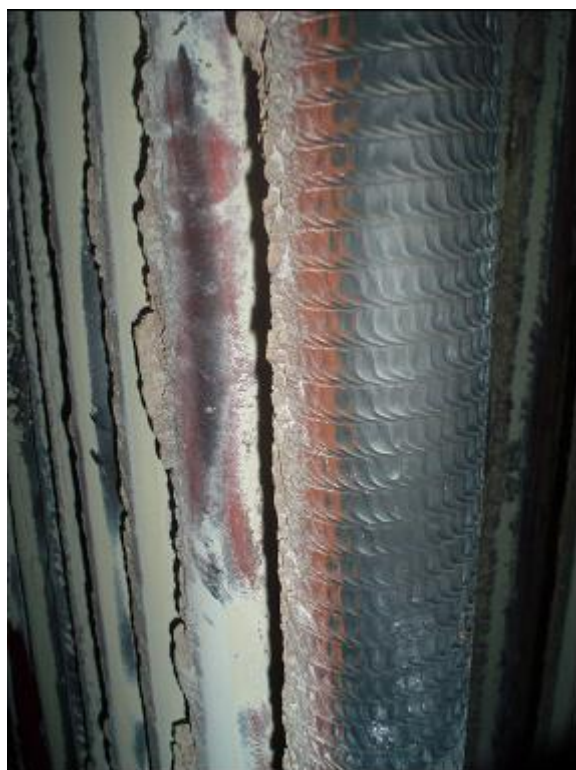
Fig. 14. SA213-T2 superheater tubes overlaid with filler metal 72, after 7 years of service in AEP's Rockport #1 plant.
